Docket No. 217 – Development and Management Plan Inspection

Northeast Utilities Service Company Certificate of Environmental Compatibility and Public Need for the construction of a 345-kV electric transmission line and reconstruction of an existing 115-kV electric transmission line between Connecticut Light and Power Company's Plumtree Substation in Bethel, through the towns of Redding, Weston, and Wilton, and to the Norwalk Substation in Norwalk, Connecticut.

Date: June 20, 2006

Location: 115 kV Underground Route

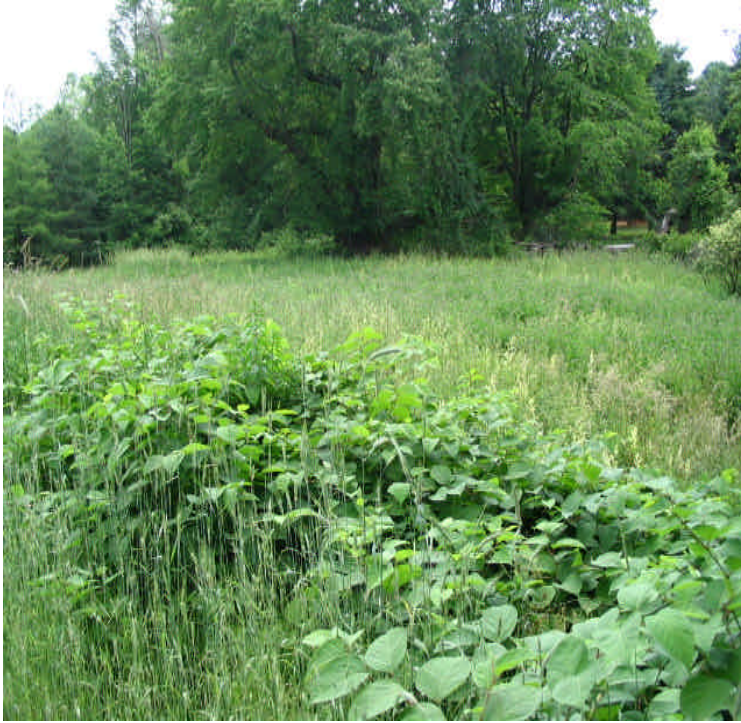
Photo on the left shows the vegetation around the erosion controls left at the old parking area across from Redding CC. Controls can be removed here. Photo on the right shows some of the efforts made along the route to topsoil and seed areas adjacent to the road. 6/20/06

| Areas of Inspection | Observation | Recommended Action | Corrective Action |
|--|---|---|---|
| | <p>- Controls at the 90 degree turn on Rt. 107 are well in place. Some tracks were noted from vehicle parking. 6/7-6/20/06</p> | <p>- The area is stabilized. Silt fence and haybales can be removed whenever feasible here. 4/26-6/20/06</p> | <p>-N/A</p> |

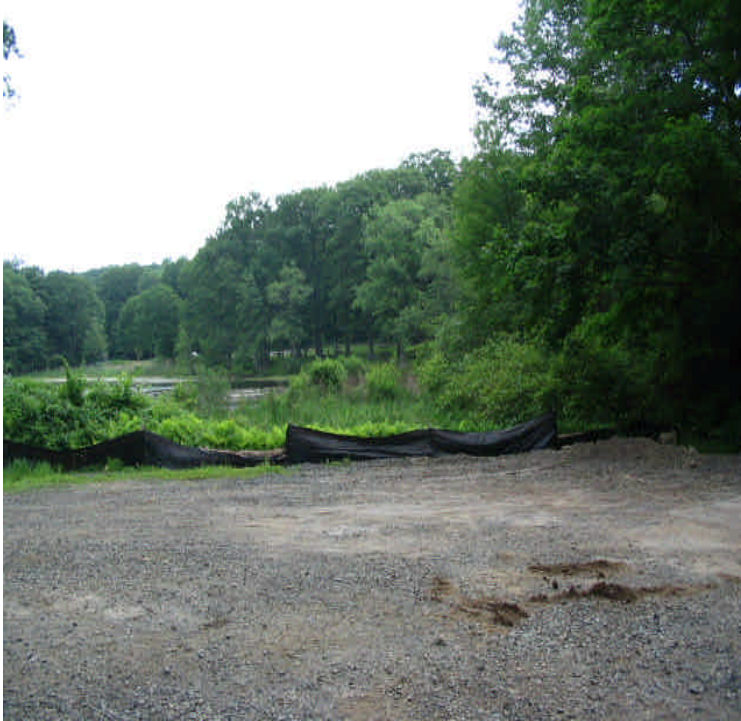
Photo on the left shows the Putnam Park storage area. Silt fence was in place along this side but a small spot along the back was pushed over by old process. Photo on the right shows the opposite side of the parking area where silt fence is down near the swale. 6/20/06

| Areas of Inspection | Observation | Recommended Action | Corrective Action |
|--|---|---|---|
| | <p>- At the Putnam Park parking area, one small area of silt fence had some stone pushed over and a section by the culvert was down. 6/14-6/20/06 (A new section of fence was noted as well. 6/20/06)</p> | <p>- Repair fence due to an adjacent soil stockpile on site. 6/14-6/20/06</p> | <p>- Some new fence was present but the area still needs some maintenance</p> |

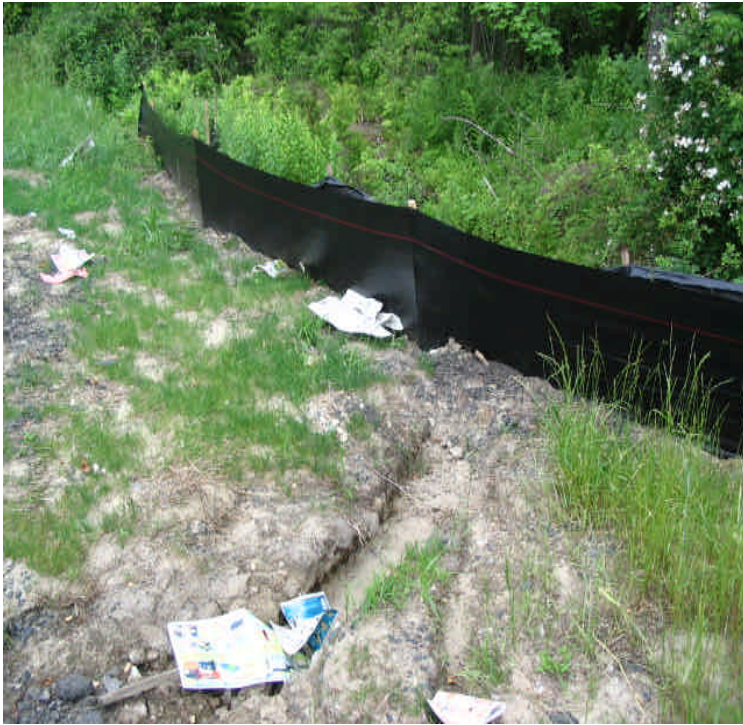
Photo on the left shows the new silt fence installed along the Sunset Hill Rd old parking area. There is still some gullying/wash-outs at this one spot but the fence is well installed Photo on the right shows the northern area of the Bethel Ed ROW well restored. 6/20/06

| Areas of Inspection | Observation | Recommended Action | Corrective Action |
|--|---|---|---|
| <p>Rt. 107 (Lonetown Rd)</p> | <p>-The edge of the Sunset Hill Rd. storage area along Rt. 58 appeared to have some additional gravel material placed here. A new line of silt fence was also installed. 6/20/06</p> | <p>- The silt fence parallel to Rt 58 was preventing sedimentation from a washout here. The rest of the fence could be removed when feasible. 6/20/06</p> | <p>- N/A</p> |

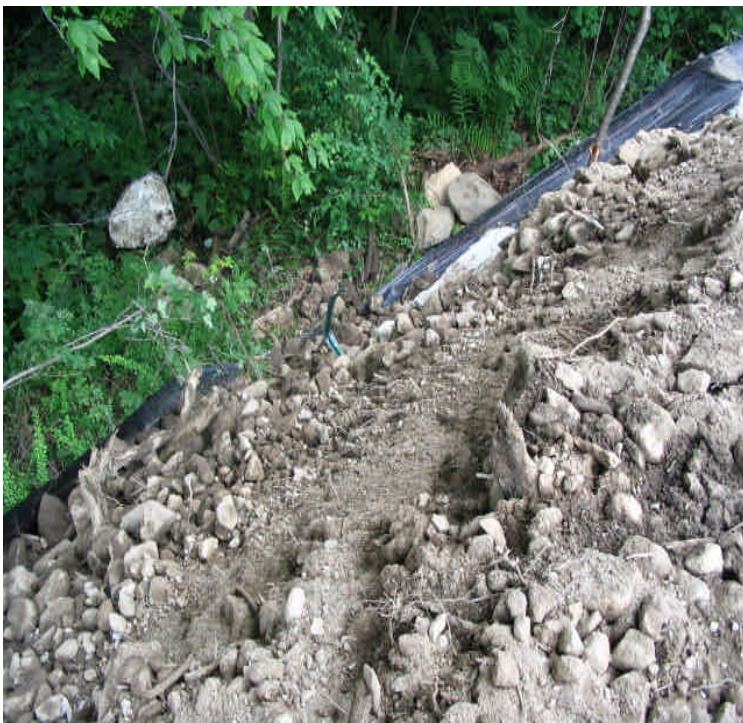
(Bethel Ed Park): Photo on the left shows where grading and a boulder rolled over the silt fence. This fence will be repaired. Consider placing erosion control mats here due to the steep grade and past history of washouts. Photo on the right shows the soccer field slope reinforced with boulders along the ROW. 6/20/06

| Areas of Inspection | Observation | Recommended Action | Corrective Action |
|--|---|---|---|
| | <p>- Boulders were installed at the southern ROW. The slope with the washouts had been graded but it may need further stabilization due to the steep gradient 6/20/06</p> | <p>- Investigate stabilization measures for this slope. Consider erosion control mats to prevent future washouts. The silt fence was also going to be righted here. 6/20/06</p> | <p>- Needs evaluation</p> |
